CALIFORNIA REGIONAL WATER QUALITY CONTROL BOARD - SAN DIEGO REGION
WATERSHED MANAGEMENT PROGRAM

FACILITY INSPECTION REPORT

INSPECTION DATE: 7/6/01 TIME: 2:00 pm WDID: 9335313938

Inspection Photos July 6,2001, North Plaza LLC
WDID # 933S 313938

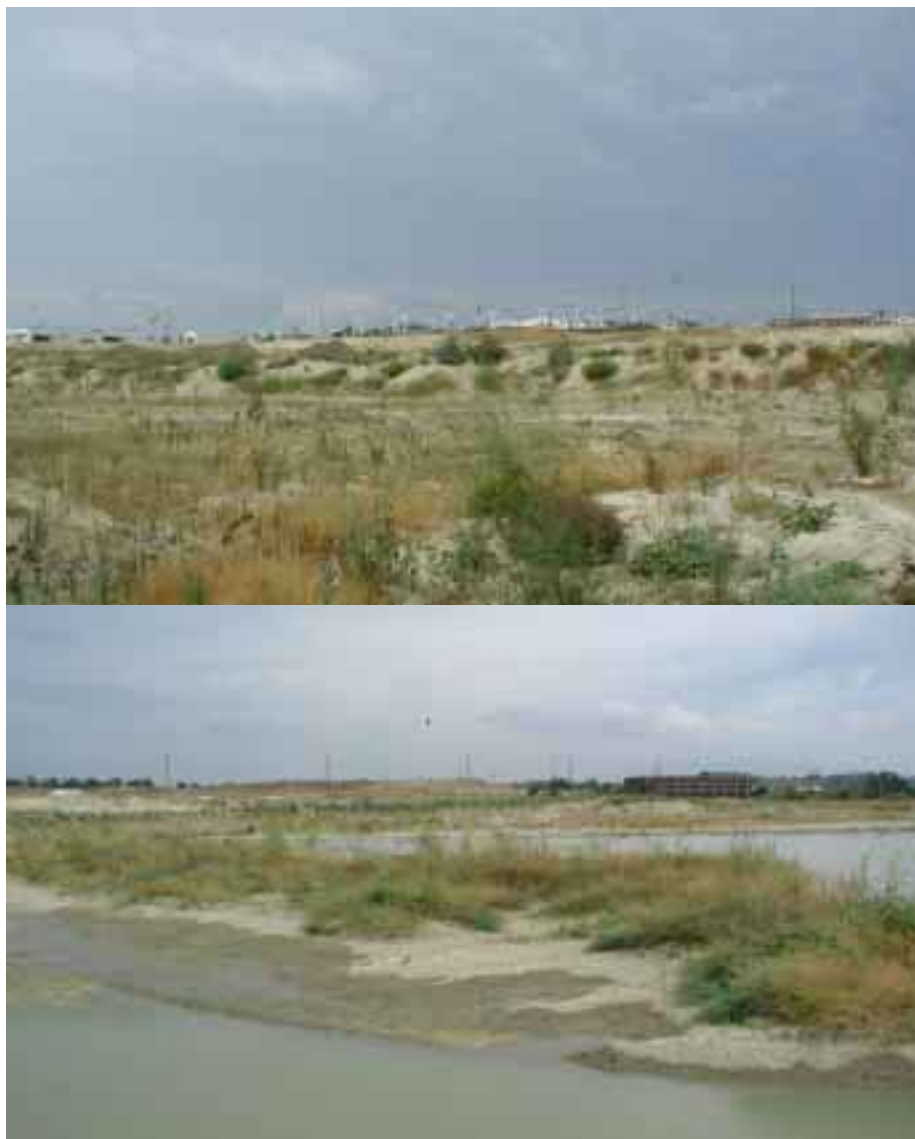
Site has become
overgrown with
vegetation, large amount
of standing water present
on-site

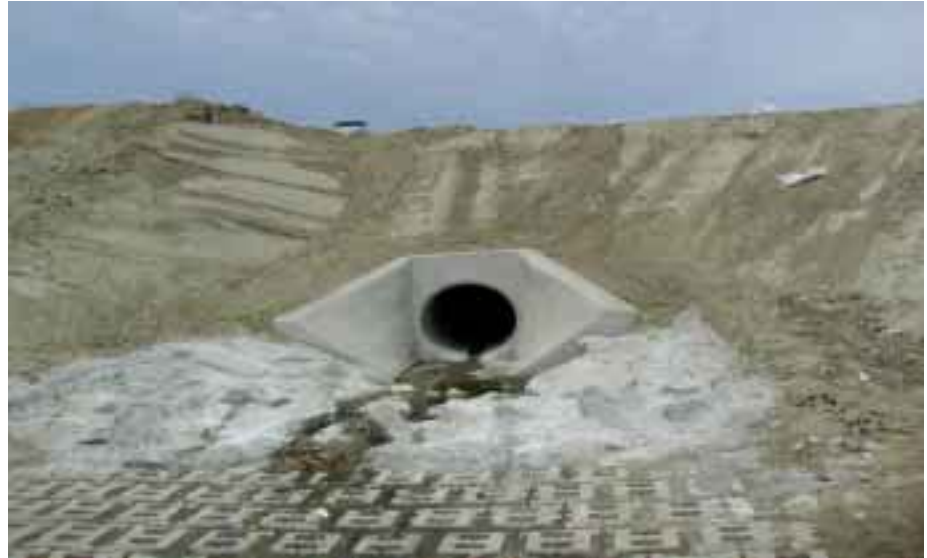
Newly constructed storm drain outlet facing I-15.

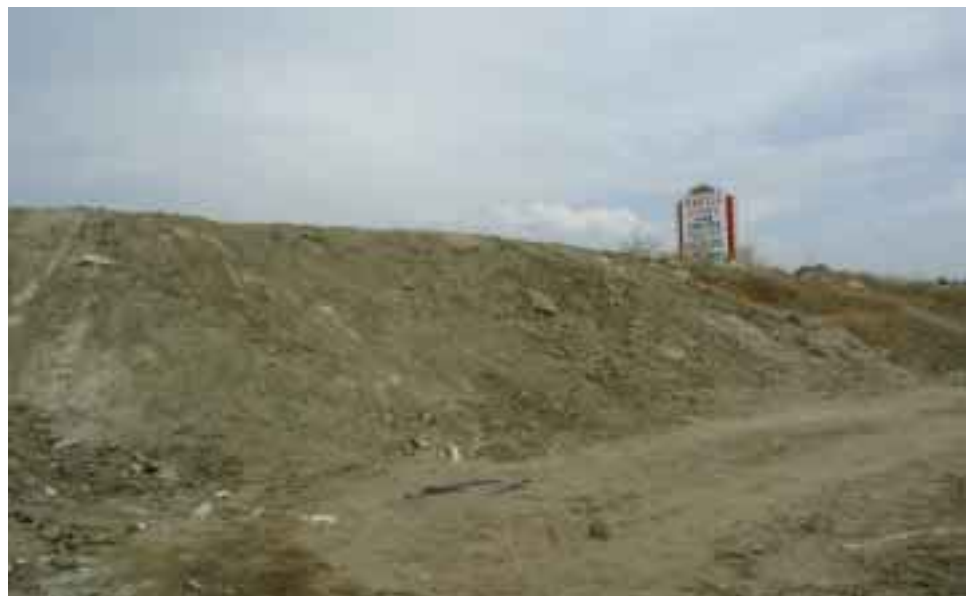
Unprotected slope section along I-15 site perimeter

Site perimeter needs to be stabilized w/ erosion controls before next rainy season.
Oil container needs to be removed and disposed of properly. Except for
the installation of storm drain system & construction of large dirt berms,
no other BMP's have been implemented to address sites previous discharge
violations. Discharges from site likely if Erosion controls are not implemented
before next rainy season.

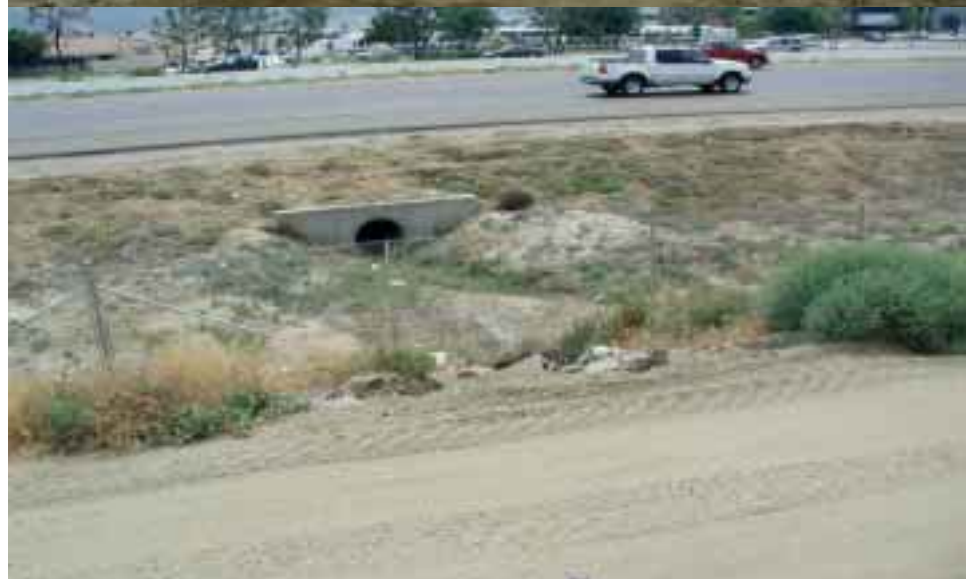
I-15 site perimeter with no BMPs in place to avoid discharge of sediment into culvert in Caltrans right-of-way

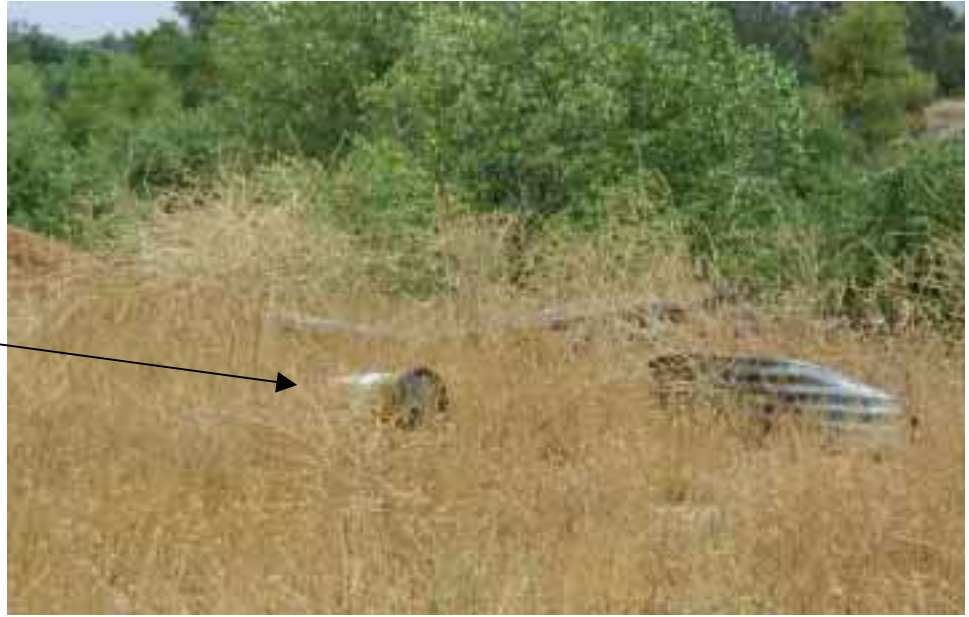
Discarded oil
container noted in
previous NOVs has
still not been
removed.
